# **COMPREHENSIVE MOTOR VEHICLE SERVICES & CONSULTING Motor Vehicle Forensic Analysis Report**

**People of the State of New York v.**  
**Nauman Hussain**

CMVSC-18-VA-253

**REFERENCED INVOLVED SUBJECT VEHICLE:** 2001 Ford Excursion Stretch Limousine,  
VIN 1FMNU40S51EB10299

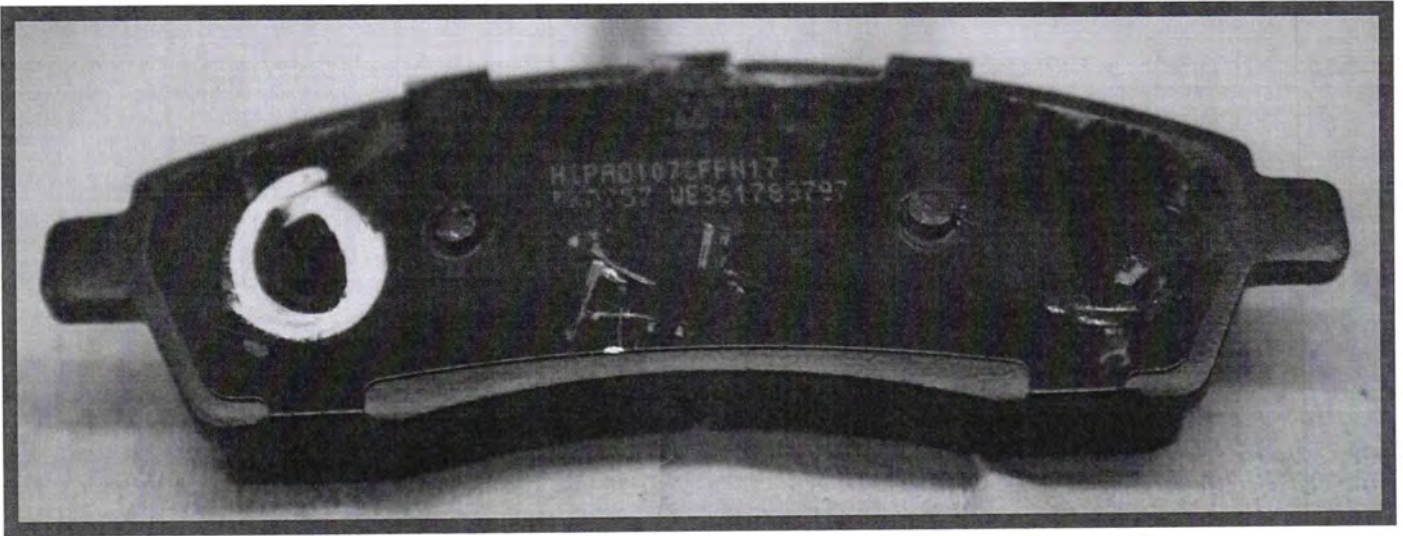
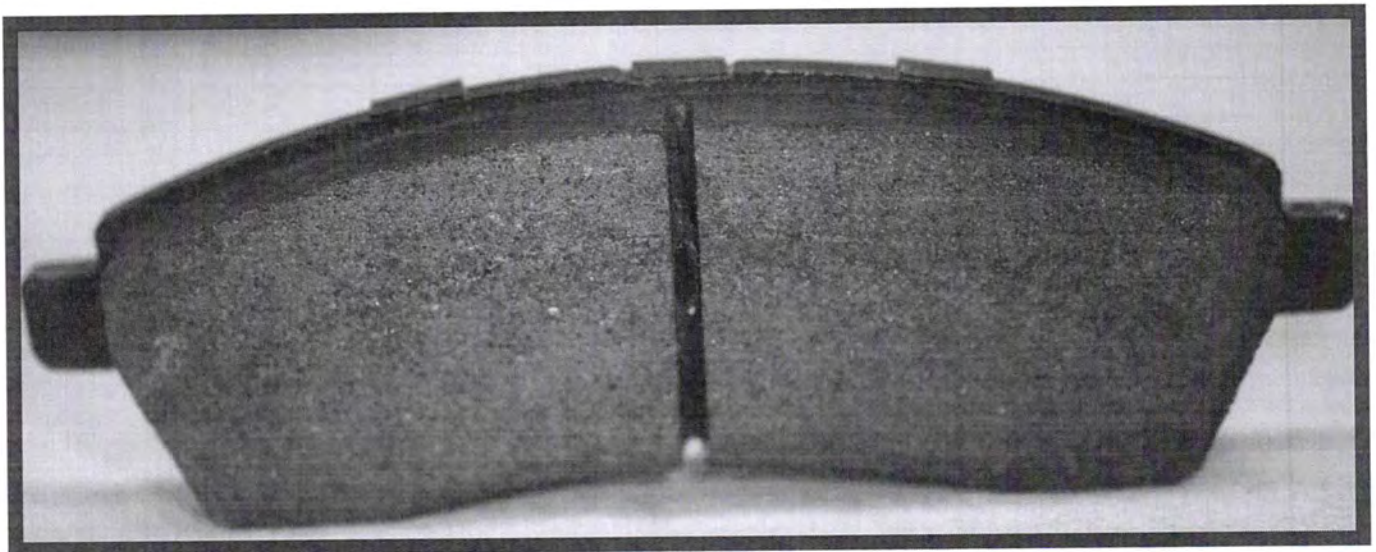
- ✓ Digital measurements of friction material thicknesses of inner and outer disc brake pads exhibited minimal discrepancies compared to digital measurements of new disc brake pads purchased for comparison, despite replacement by Mavis Discount Tire on May 11, 2018.
- ✓ Bonded design disc brake pads, semi-metallic composition.
- ✓ Brake dust presence nearly nonexistent.
- ✓ No thermal distress noted.
- ✓ Original black steel foundation plate paint clearly evident.
- ✓ Inner disc brake pad friction material exhibited embedded corrosion deposits, with no evidence of scoring wear from severely scored inner left rear disc brake rotor swept area.

**Images No.20a & 20b.** These photographs depict the outer disc brake pad (above photograph) and inner disc brake pad (bottom photograph) of the involved 2001 Ford Excursion stretch limousine. Note the obvious "as new" appearance inclusive of intact original black paint and absence of inner disc brake pad friction material striations resulting from brake force at scored inner disc brake rotor swept area.

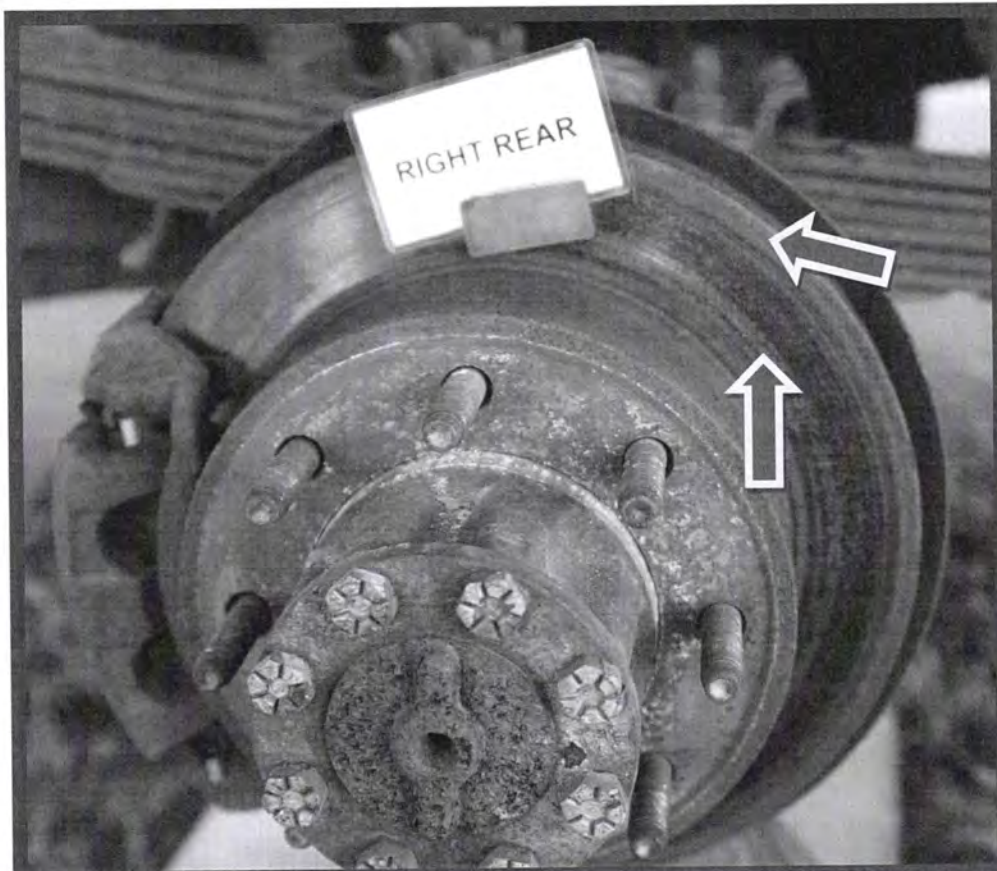
**Image No.21.** This photograph depicts the right rear disc brake components of the involved 2001 Ford Excursion stretch limousine prior to removal from the vehicle. Note the outer disc brake rotor swept area corrosion, which was a pre-existing condition (Red Arrows).

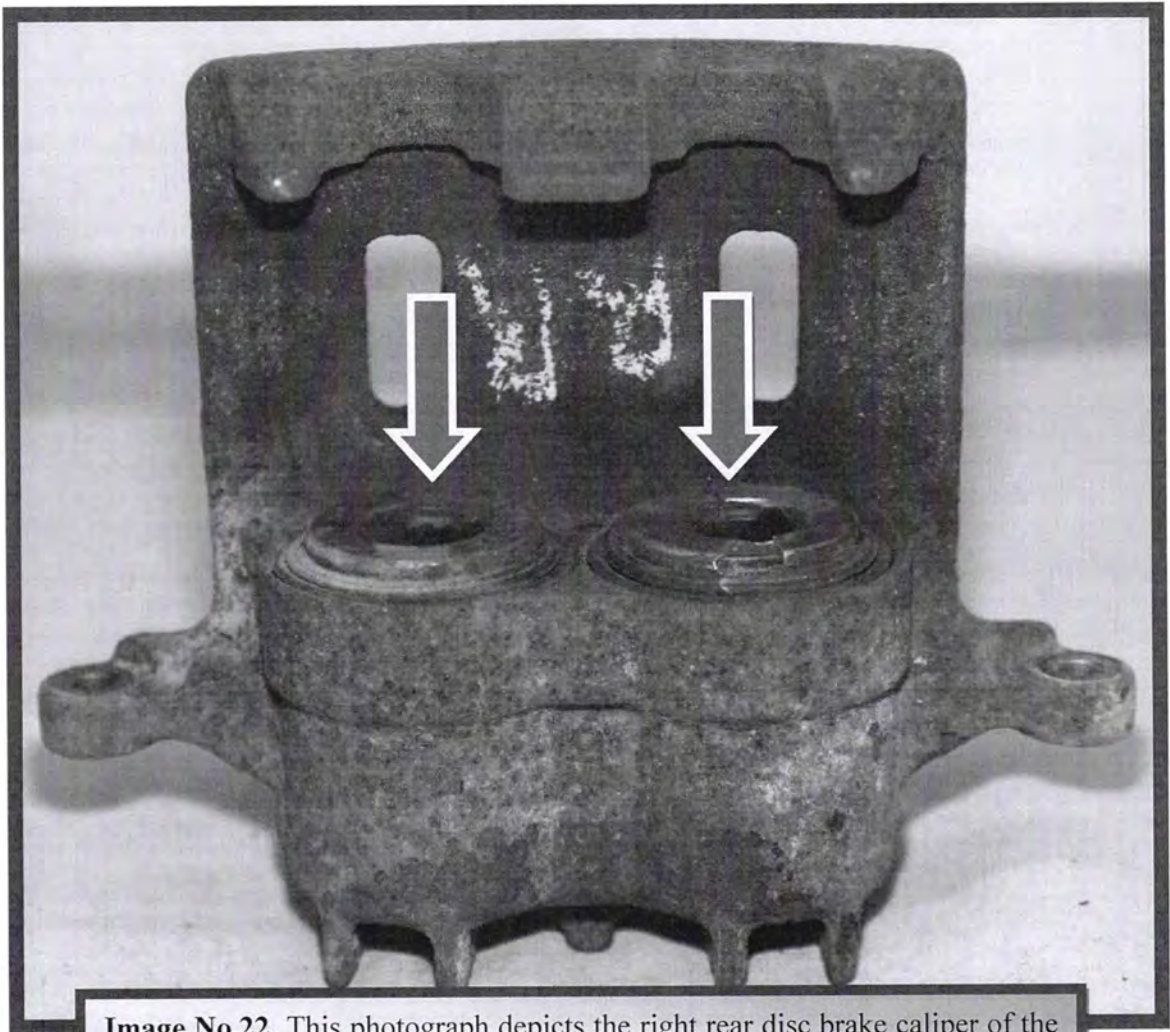
Disc Brake Caliper, Right Rear – The right rear disc brake caliper of the 2001 Ford Excursion stretch limousine exhibited prominent casting corrosion; corrosion/pitting at the outer disc brake pad flange; and remarkable corrosion at the bleeder valve area. The two brake caliper pistons were seized within the respective caliper housing bores, rendering brake force nonexistent at the right rear wheel location. This condition was pre-existing.

**Image No.22.** This photograph depicts the right rear disc brake caliper of the involved 2001 Ford Excursion stretch limousine prior to removal from the vehicle. Note the prominent corrosion -- the caliper was that of an older design, with steel composition pistons as opposed to phenolic pistons. The two caliper pistons were seized within their respective bores of the caliper body (Blue Arrows) -- a pre-existing condition.

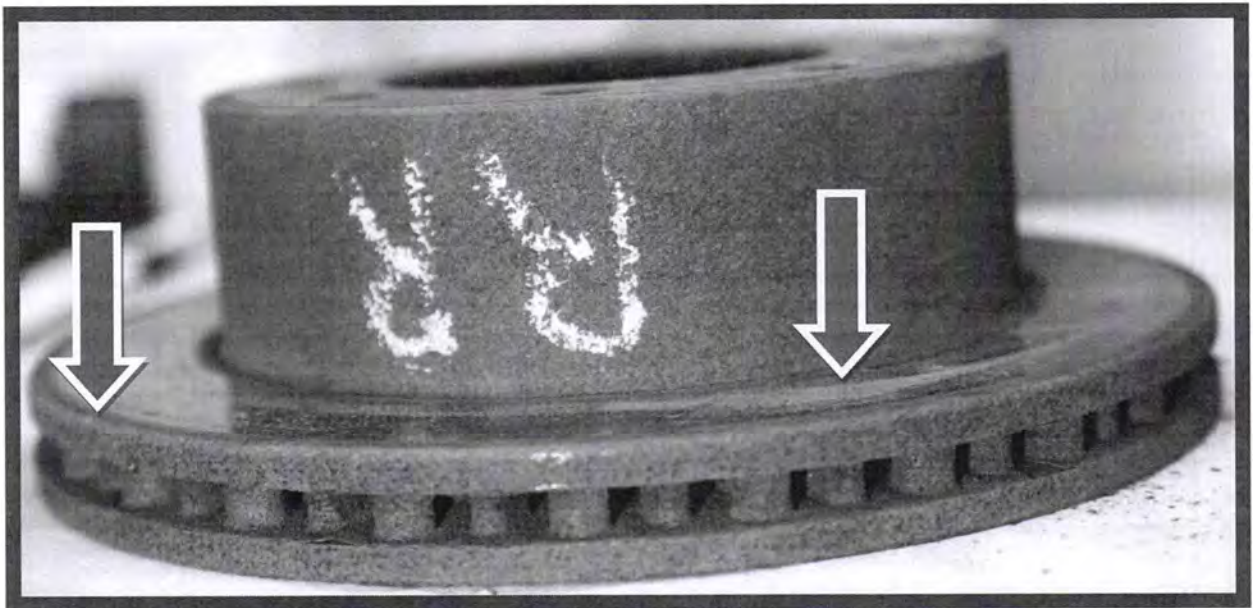
- ✓ No thermal distress noted.
- ✓ Minimal brake dust presence.
- ✓ Outer swept area exhibited corrosion, oxidation, pitting, and scoring.
- ✓ Inner swept area exhibited corrosion, pitting, and scoring.
- ✓ Condition consistent with deficiencies in effective brake effort.
- ✓ Disc brake rotor was not machined/replaced during brake service conducted by Mavis Discount Tire on May 11, 2018.
- ✓ Minimum measured right rear disc brake rotor thickness = 1.183". Original disc brake rotor thickness = 1.185". Minimum disc brake rotor thickness specification = 1.10". Minimum disc brake rotor thickness to machine rotor specification = 1.12".
- ✓ Reduced brake component cooling due to heavy corrosion at cooling fins.

**Image No.23.** This photograph depicts the right rear disc brake rotor of the involved 2001 Ford Excursion stretch limousine during the period of individual component analysis. Note the oxidation/corrosion present at the outer rotor swept area, as well as absence of wear evidence from braking since replacement in 2016. (Red Arrows), consistent with the previously described condition of pre-existing seized brake caliper pistons which prevented brake application at the right rear wheel location.

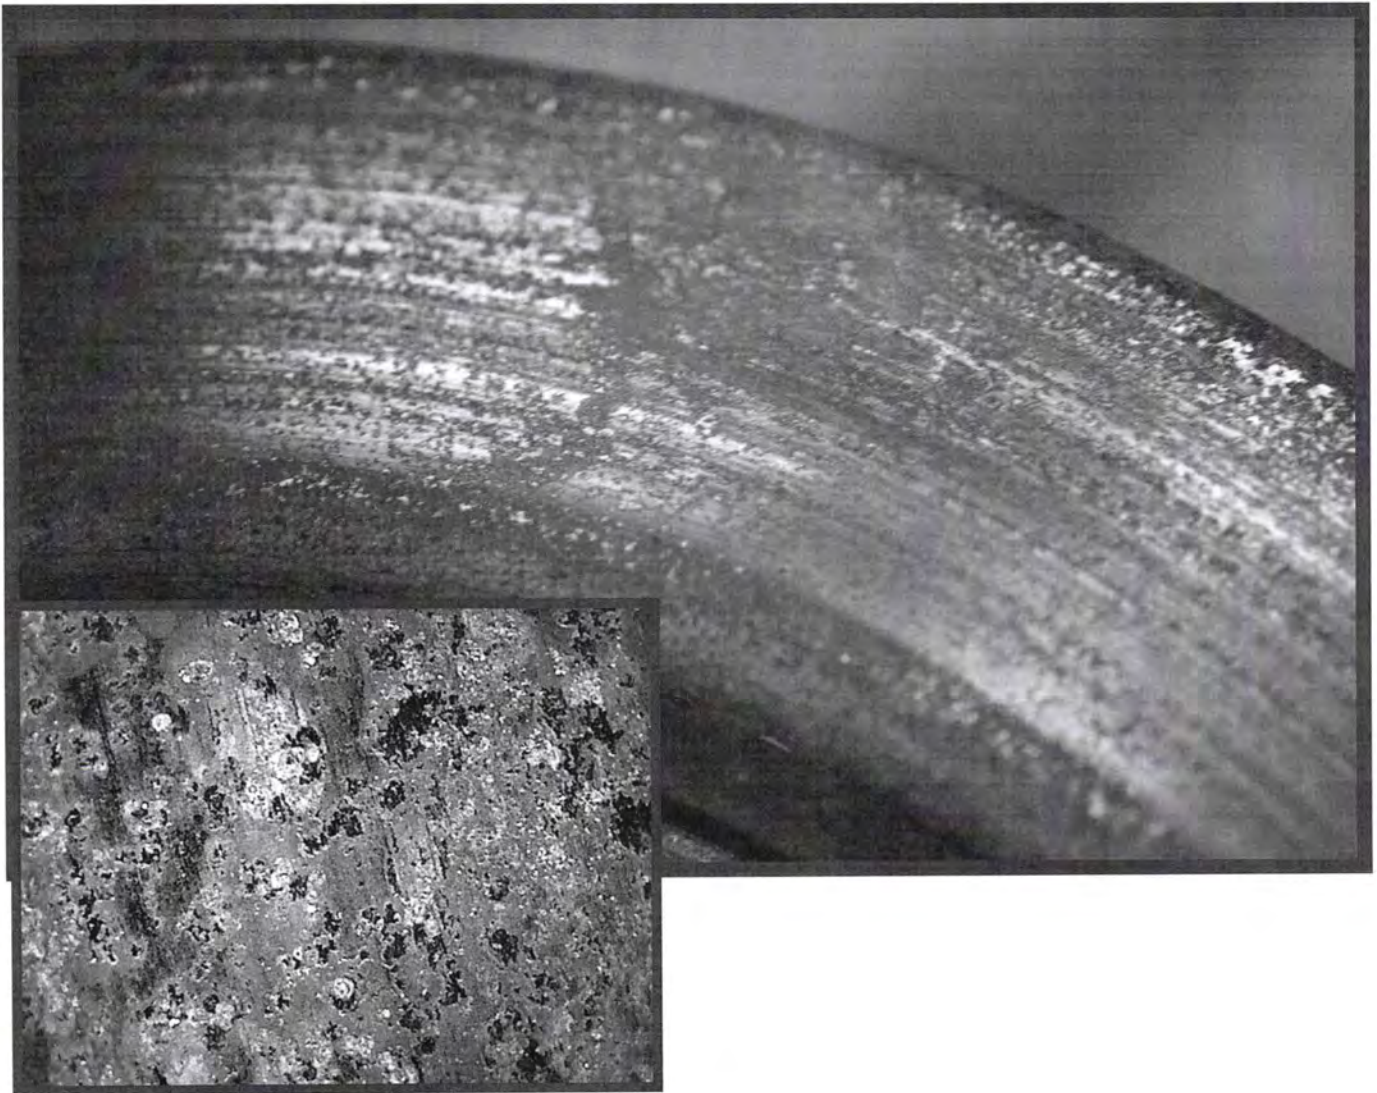
**Image No.24.** This photograph depicts the inner swept area of the right rear disc brake rotor of the involved 2001 Ford Excursion stretch limousine during the period of individual component analysis. Note the oxidation/corrosion/pitting present within the outer rotor swept area, as well as absence of wear evidence from braking since replacement in 2016, consistent with the previously described condition of pre-existing seized brake caliper pistons which prevented brake application at the right rear wheel location. Insert digital microscope image denotes swept area surface.

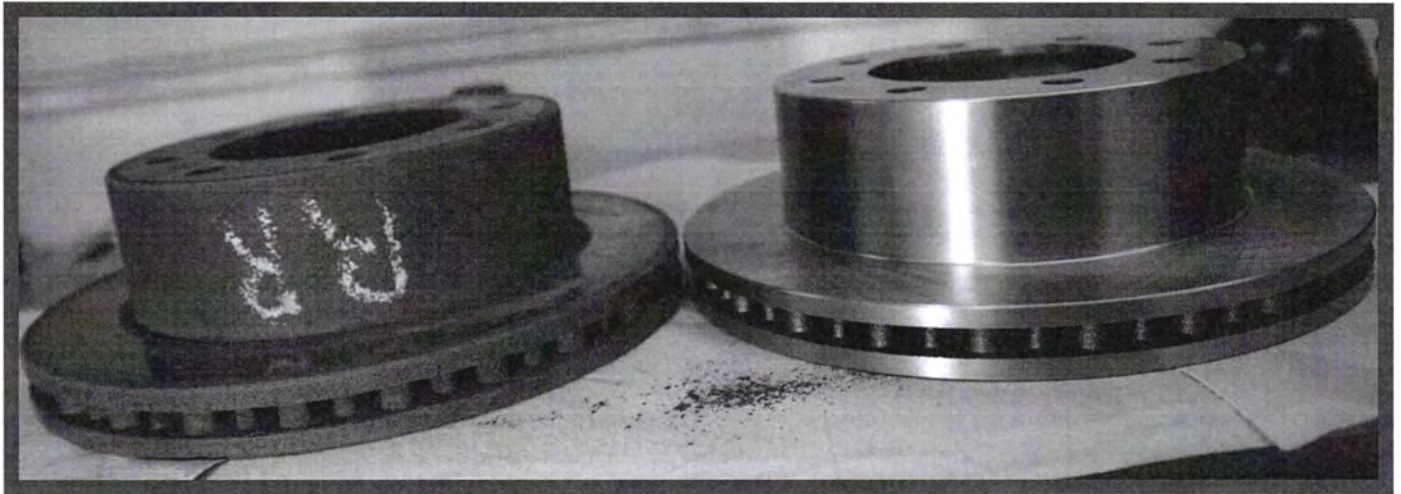
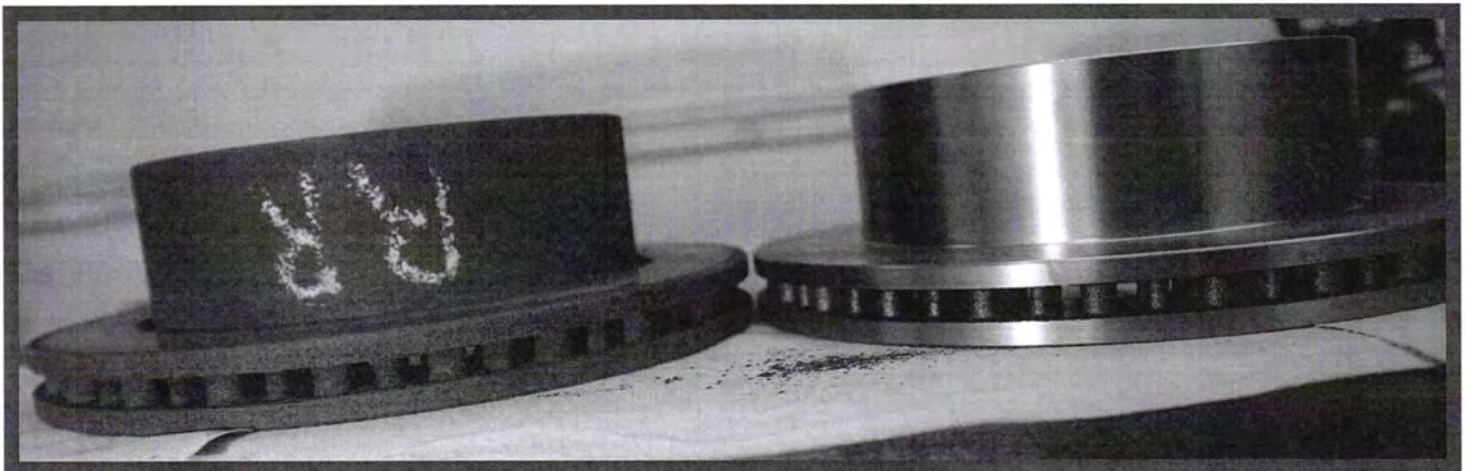
**Images No.25a & 25b.** These photographs depict the comparison of the right rear disc brake rotor of the involved 2001 Ford Excursion stretch limousine to a new replacement disc brake rotor. Note that the removed rotor thickness and lack of wear ridge is consistent with the previously described condition of pre-existing seized brake caliper pistons which prevented brake application at the right rear wheel location.

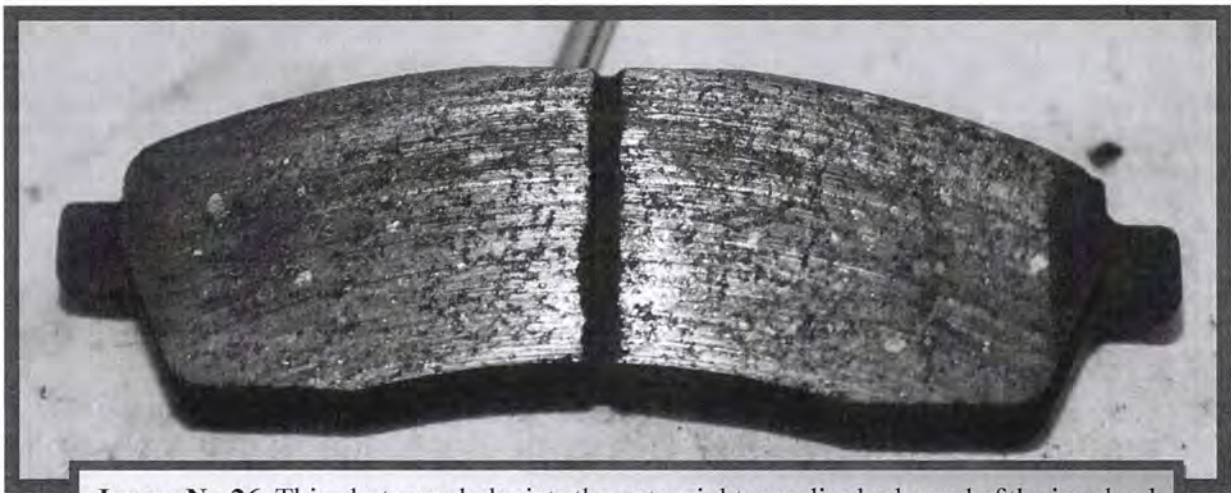
**Image No.26.** This photograph depicts the outer right rear disc brake pad of the involved 2001 Ford Excursion stretch limousine. The friction material exhibited slight scoring, pitting, and contaminants.

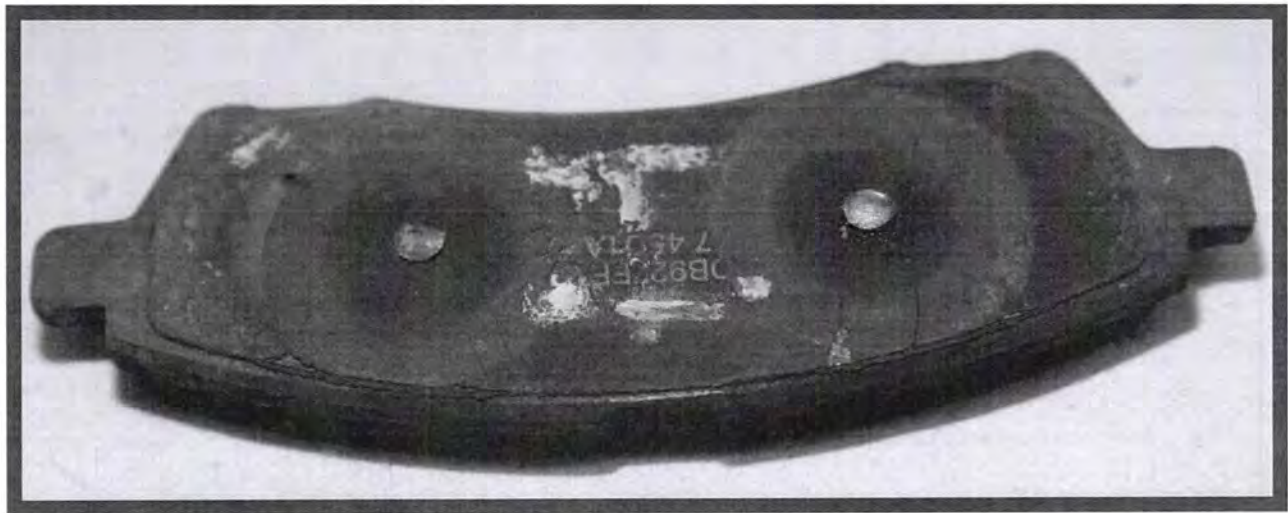
**Image No.27.** This photograph depicts the inner right rear disc brake pad of the involved 2001 Ford Excursion stretch limousine. Obvious corrosion was present at the inner/outer disc brake pad shim; abutment clip locations; and caliper piston/pad shim interfaces.

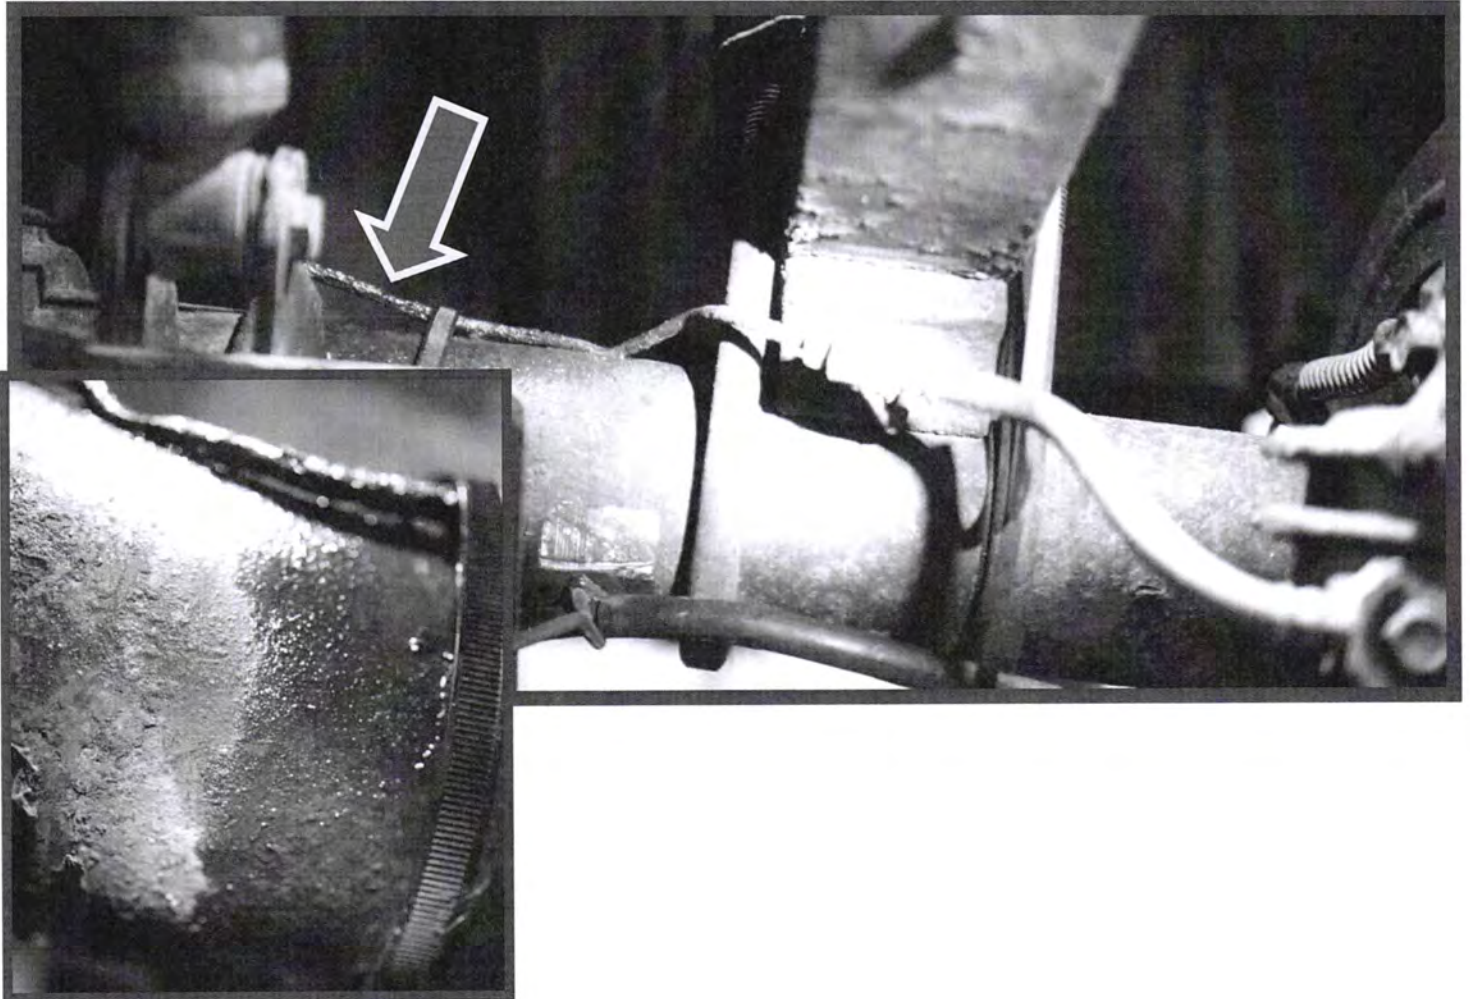
**Brake Tubing, Right Rear** – The examination of the steel composition, rear crossover brake tubing located on the rear differential housing of the involved 2001 Ford Excursion stretch limousine revealed that the section of tubing had experienced failure of integrity, with resulting loss of brake fluid, due to pre-existing critical tubing corrosion. This loss of integrity is typically associated with considerable brake pedal force executed by the operator of the vehicle.

Due to the mandated split service design of the hydraulic braking system of the 2001 Ford Excursion stretch limousine, this loss of integrity at the right rear crossover brake tubing would result in overall brake failure at both left and right rear wheel locations of the vehicle -- braking of the 2001 Ford Excursion stretch limousine would be totally dependent upon the left and right front brake components only.

**Image No.28.** This photograph depicts the rear crossover section of brake tubing, at the right rear differential housing axle tube of the 2001 Ford Excursion stretch limousine. The obvious perilous corrosion of the length of steel composition brake tubing resulted in a catastrophic loss of integrity (Red Arrow), with brake fluid loss clearly discernible from the insert photograph. The loss of integrity resulted in no braking action at the left and right rear wheel locations.

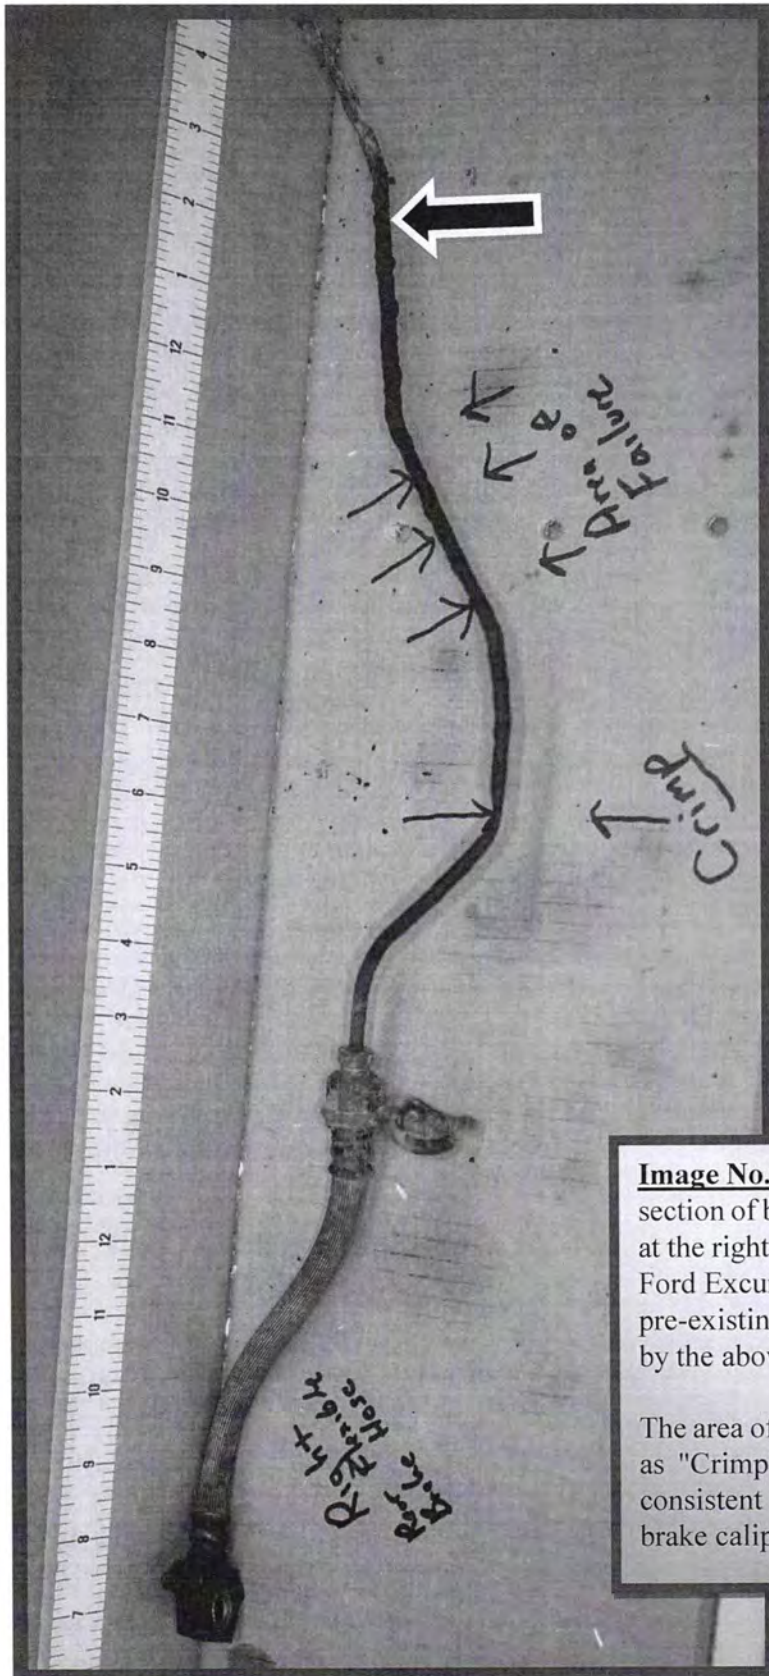
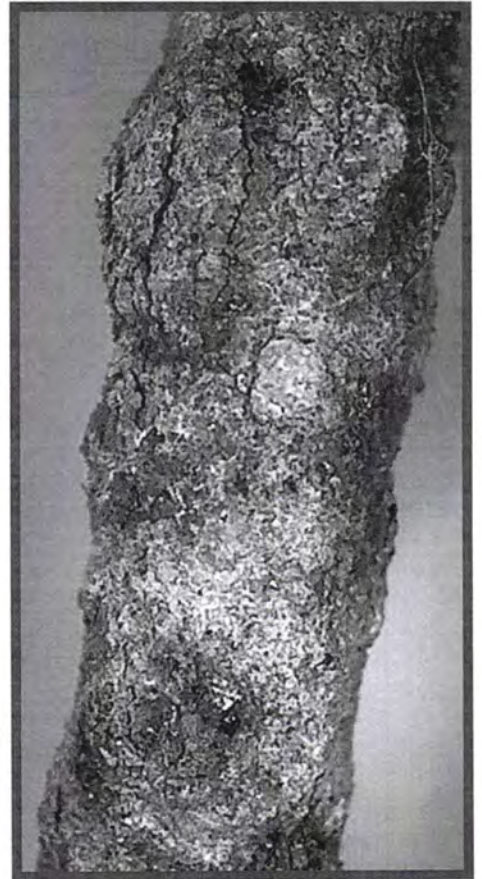
**Image No.29.** This photograph depicts the rear crossover section of brake tubing, removed from the design location at the right rear differential housing axle tube of the 2001 Ford Excursion stretch limousine. The obvious extent of pre-existing corrosion can be readily denoted, as depicted by the above photograph in the area of the Black Arrow.

The area of the steel composition brake tubing designated as "Crimp" is that of partially collapsed brake tubing, consistent with improper removal of the right rear disc brake caliper of the vehicle.

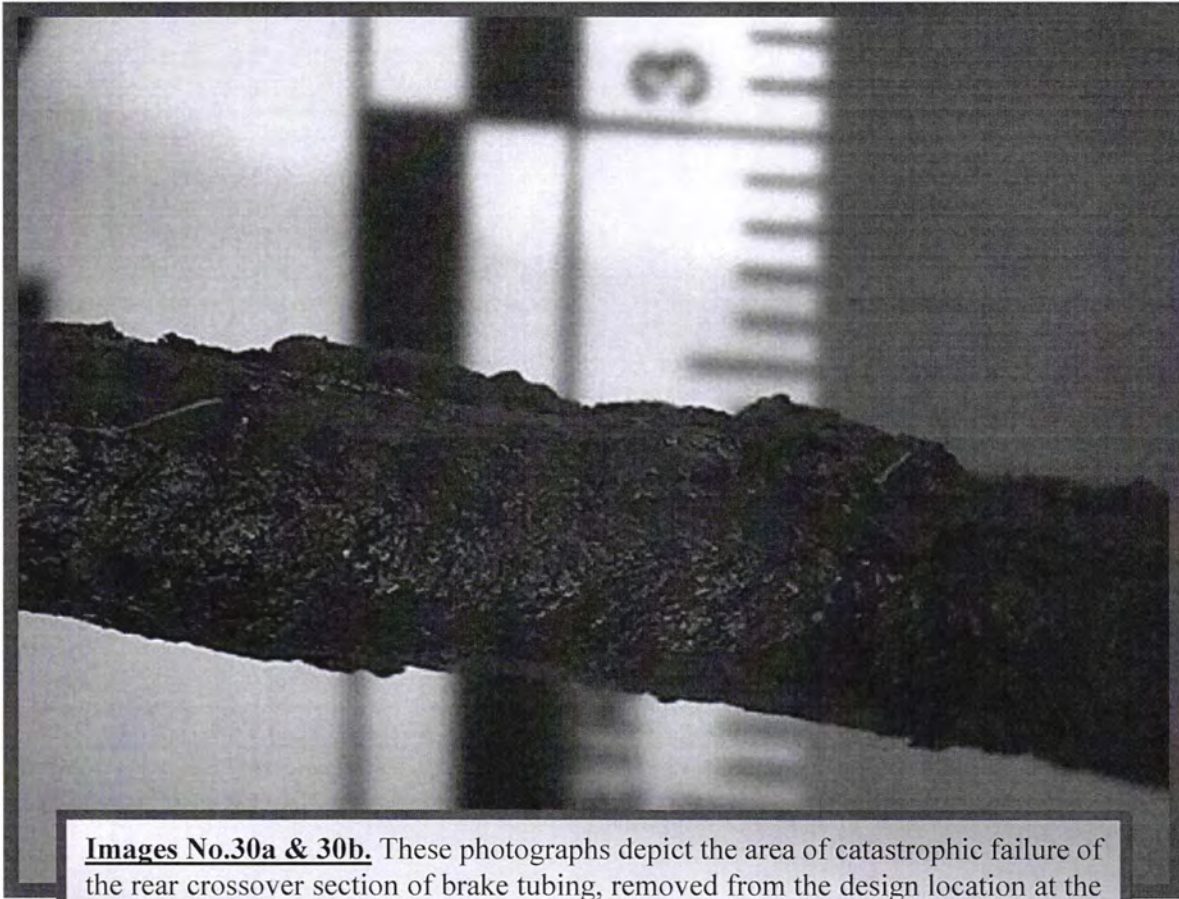
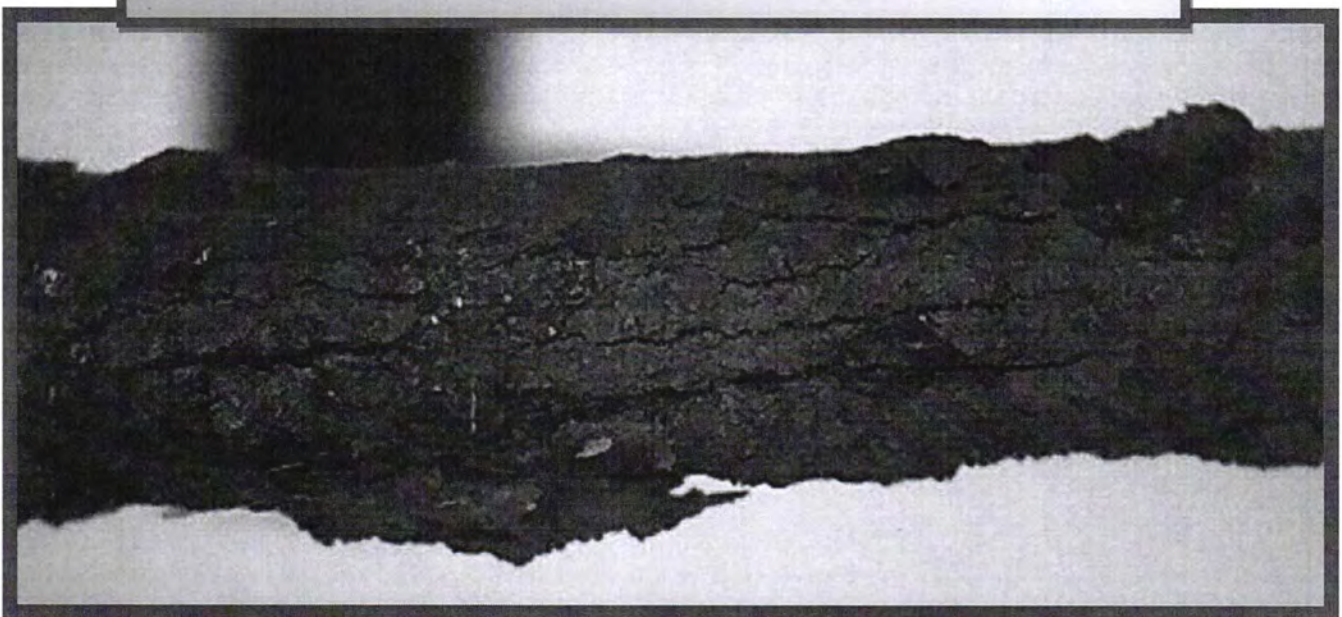
**Images No.30a & 30b.** These photographs depict the area of catastrophic failure of the rear crossover section of brake tubing, removed from the design location at the right rear differential housing axle tube of the 2001 Ford Excursion stretch limousine. Again, the obvious extent of pre-existing corrosion can be readily denoted.

**Summary of Forensic Analysis, Right Rear Brake System Components:** *No braking effort whatsoever in effect at the right rear wheel location of the 2001 Ford Excursion stretch limousine. Condition was pre-existing, as supported by forensic evidence and the absence of obvious brake dust at locations inclusive of the right rear alloy wheel.*

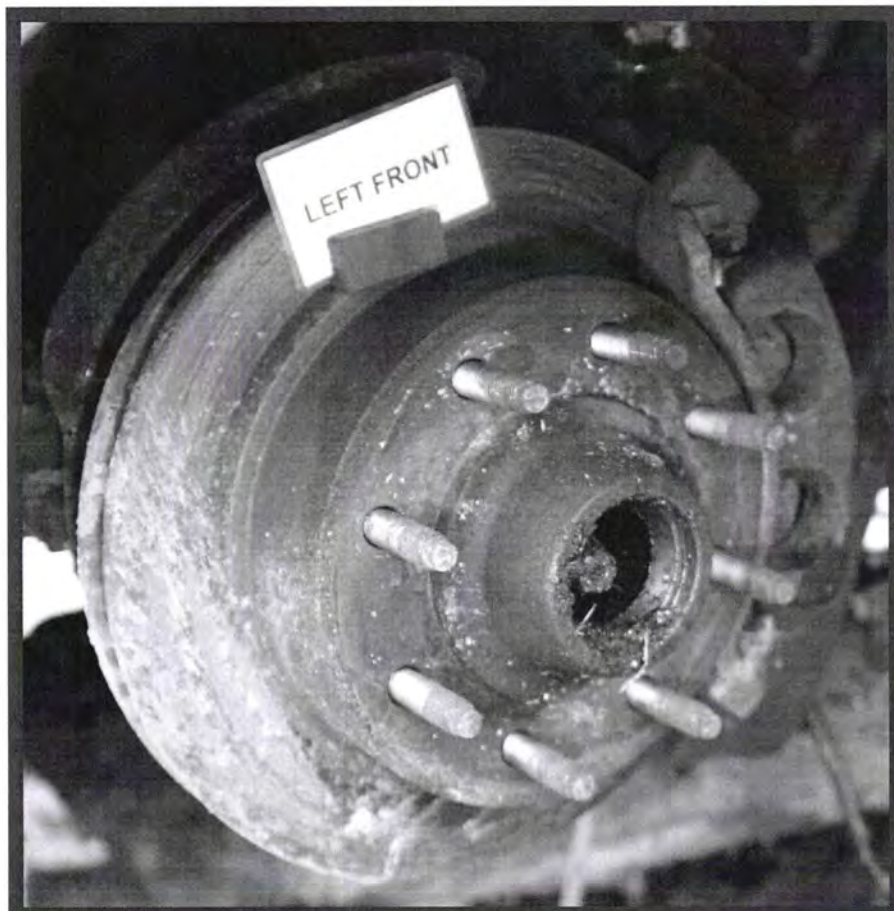
**Image No.30.** This photograph depicts the left front disc brake components of the 2001 Ford Excursion stretch limousine. The violent crash forces resulted in abstraction of the outer wheel bearing, washer, and spindle nut. The pungent odor of burnt materials/components was overpowering at the time of examination.

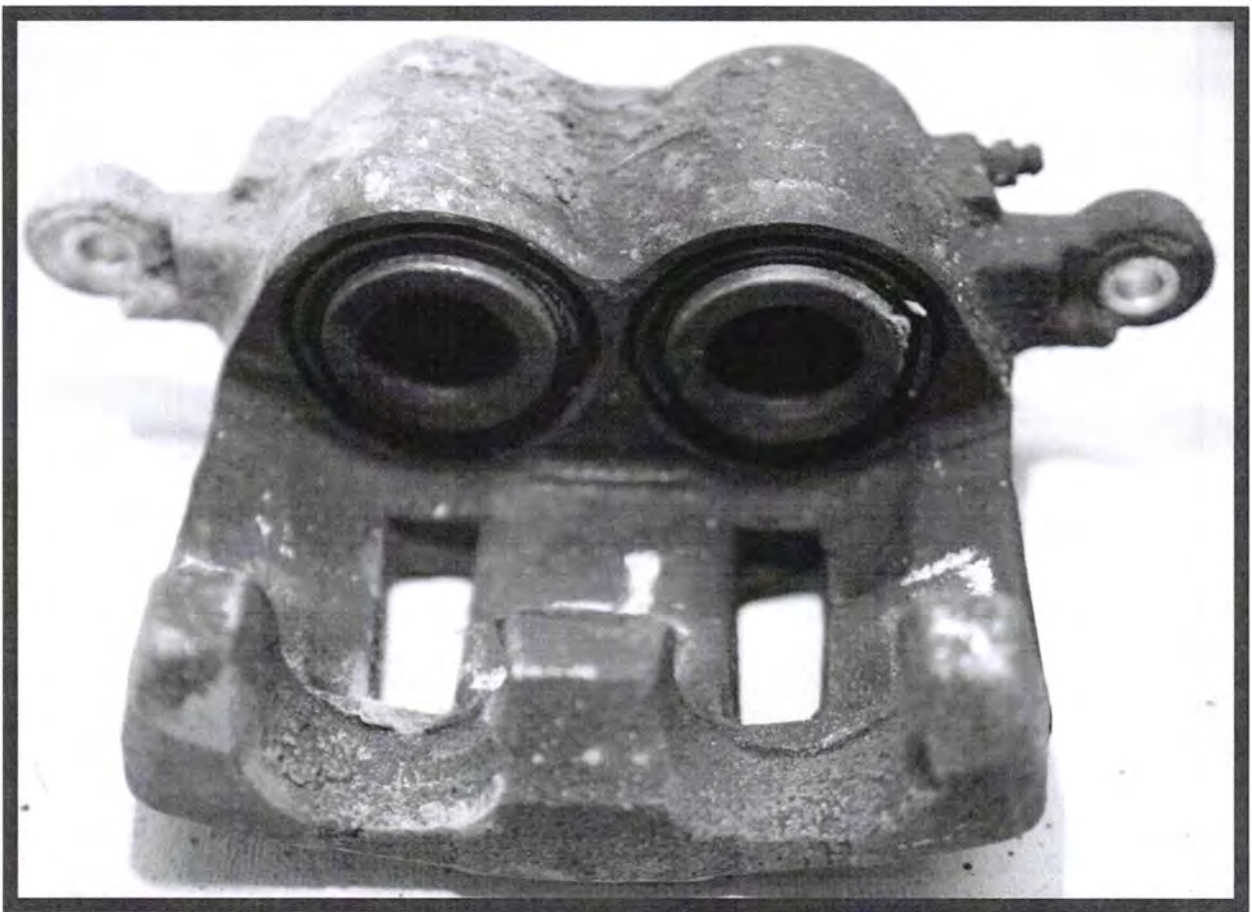
**Disc Brake Caliper, Left Front** – The left front disc brake caliper of the 2001 Ford Excursion stretch limousine exhibited prominent casting thermal distress with an intense odor of burnt materials/components. The flexible brake hose fitting had been sheared at the casting housing, consistent with impact forces. The two disc brake caliper pistons were of the phenolic composition, presenting proper expansion and seal retraction. The examination of the two piston bores following piston removal revealed slight scoring, slight pitting, and evidence of brake fluid contamination.

**Image No.31.** This photograph depicts the left front disc brake caliper of the 2001 Ford Excursion stretch limousine during the period of individual component analysis. The effects of severe thermal distress were clearly evident, including the intense pungent odor of burnt materials/components.

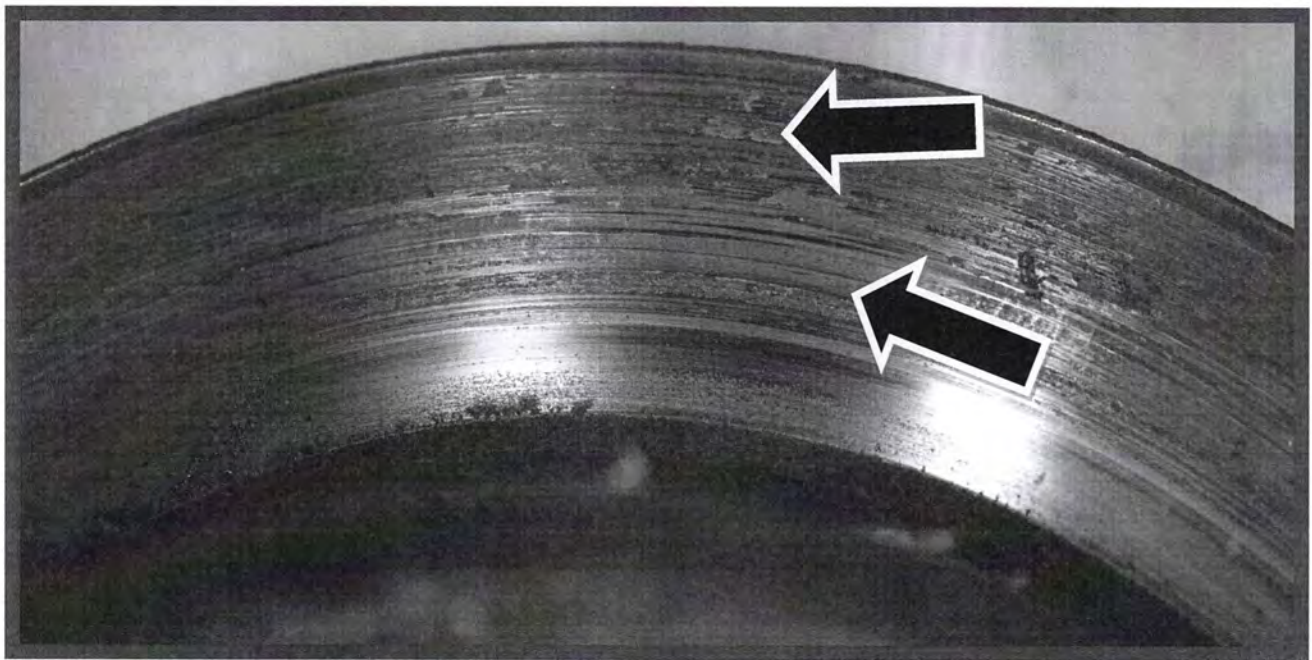
- ✓ Outer swept area presented scoring, pitting, corrosion, and embedded brake pad friction material.
- ✓ No brake dust detected due to prior extreme component temperatures.
- ✓ Inner swept area exhibited corrosion, oxidation, pitting, scoring, and embedded brake pad friction material.
- ✓ Condition consistent with extreme thermal distress from brake effort.
- ✓ Rotor vent area exhibited hardened deposits of burnt material.
- ✓ Reduced brake component cooling due to heavy corrosion at cooling fins.
- ✓ Notable scoring, inner bearing race.
- ✓ Minimum measured left front disc brake rotor thickness = 1.502". Minimum disc brake rotor thickness specification = 1.410". Minimum disc brake rotor thickness to machine rotor specification = 1.440".

**Image No.32.** This photograph depicts the outer swept area of the left front disc brake rotor of the 2001 Ford Excursion stretch limousine during the period of individual component analysis. The effects of severe thermal distress were clearly evident, including embedded material consistent with thermal deterioration of disc brake pad friction material (Black Arrows).

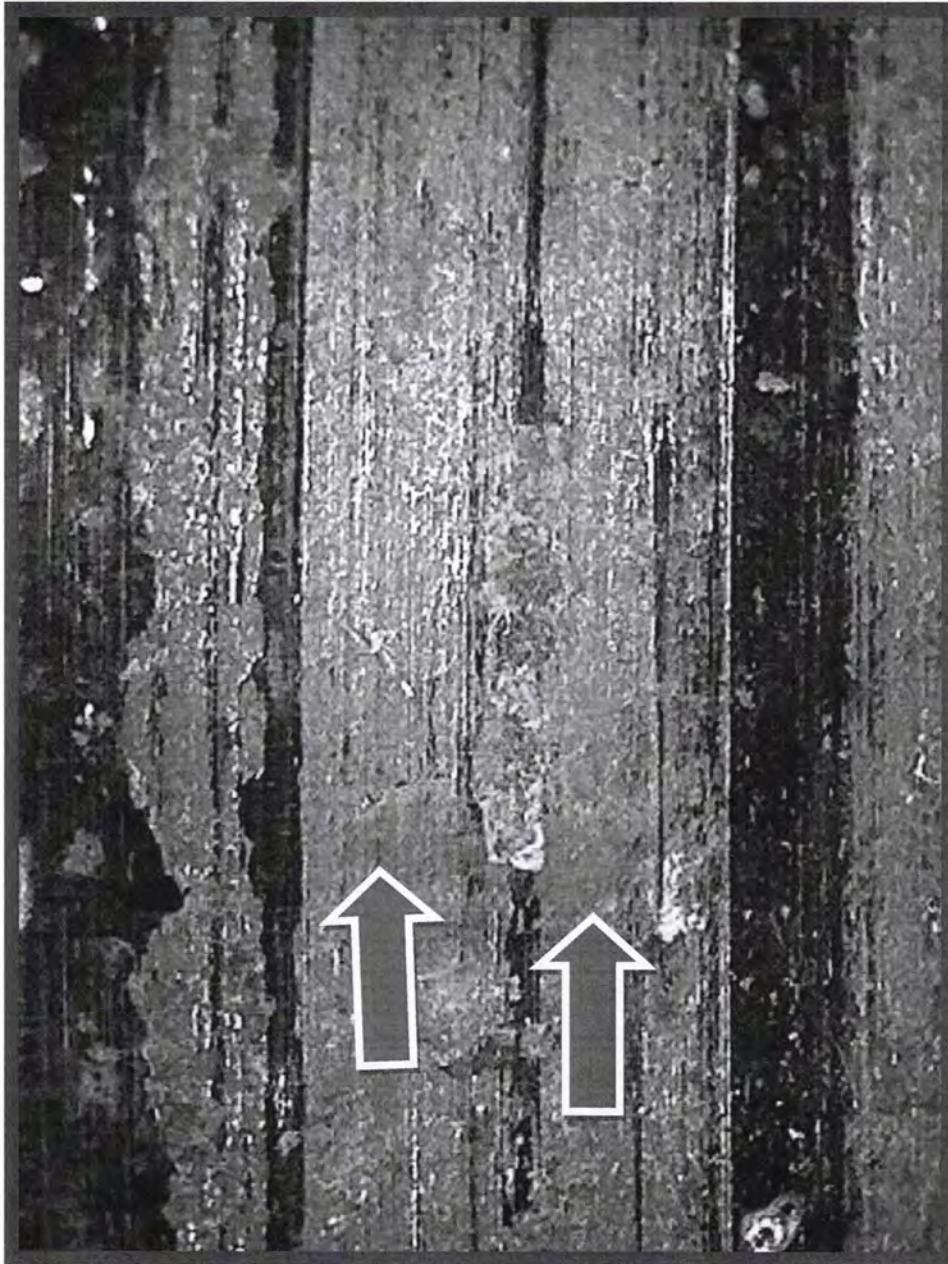
**Image No.33.** This digital microscope image depicts the inner swept area of the left front disc brake rotor of the 2001 Ford Excursion stretch limousine during the period of individual component analysis. The effects of severe thermal distress were clearly evident, including embedded material consistent with thermal deterioration of disc brake pad friction material (Red Arrows).

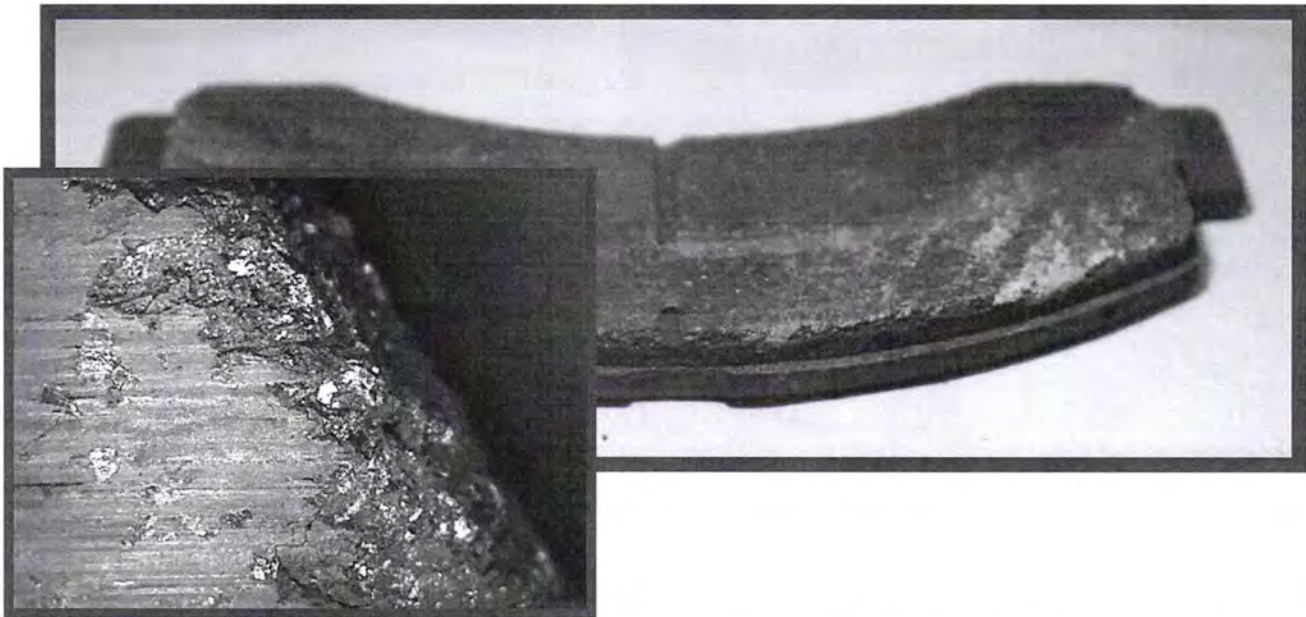
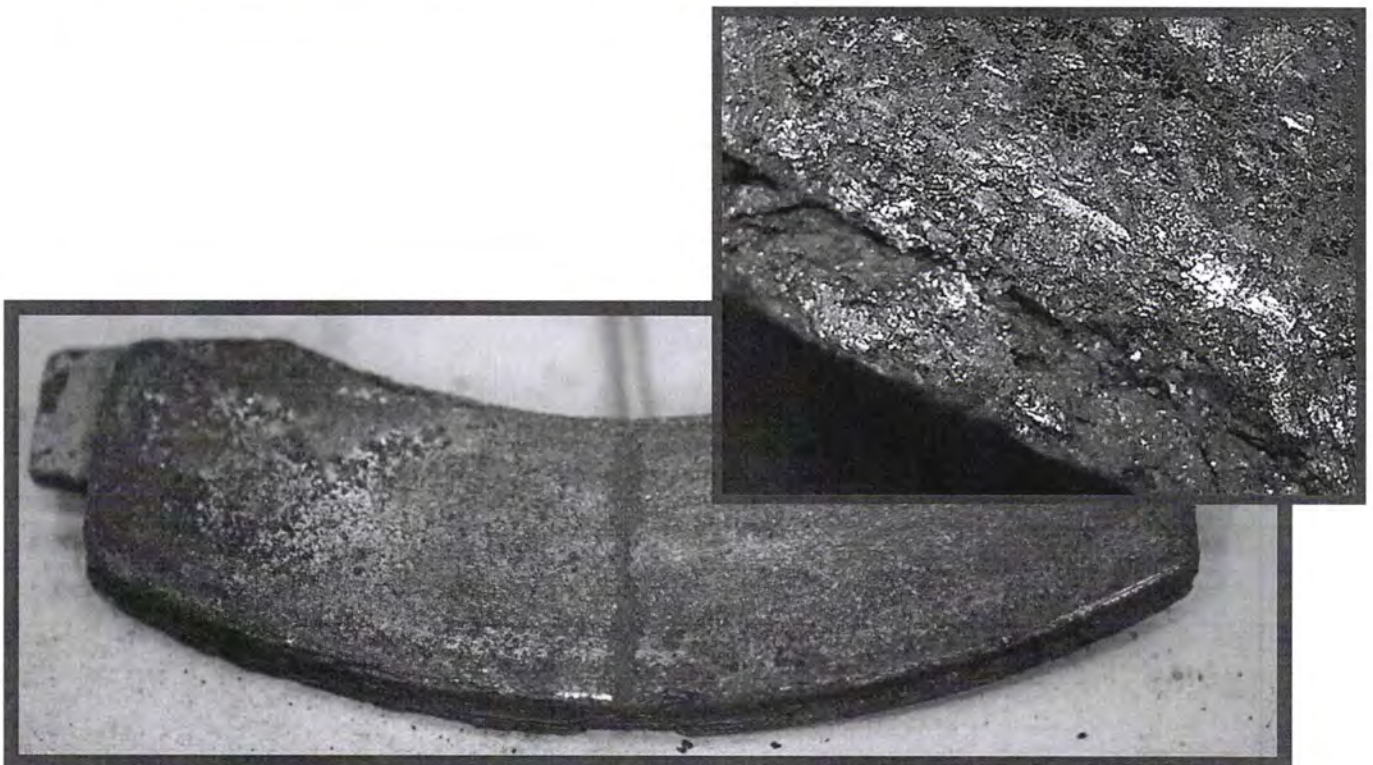
- ✓ Digital measurements of friction material thicknesses of outer disc brake pad 0.248" - 0.312", with tapered wear. Original friction material 0.443". Corrosion present at abutment clip locations.

- ✓ Digital measurements of friction material thicknesses of inner disc brake pad 0.210" - 0.281", with tapered wear. Original friction material 0.443". Corrosion present at abutment clip locations.

- ✓ Bonded design disc brake pads, semi-metallic composition.
- ✓ No brake dust detected due to prior extreme component temperatures.
- ✓ Obvious thermal distress noted, inclusive of embedded glazing deposits and obvious burnt material odor.

**Images No.34a & 34b.** These photographs depict the outer disc brake pad friction material (above photograph, with insert) and the inner disc brake pad friction material (below photograph, with insert) of the left front disc brake pads of the 2001 Ford Excursion stretch limousine during the period of individual component analysis. The effects of severe thermal distress were clearly evident, including delamination and glazing.
